**Pre-subsidence Survey  
Prior to Full Extraction at Panels**

**1 – 4 North,  
1 – 5 and 7 – 13 West,  
8 South, and  
5 West Mains**

Emery Mine  
Consolidation Coal Company  
Emery County, Utah

June 2008

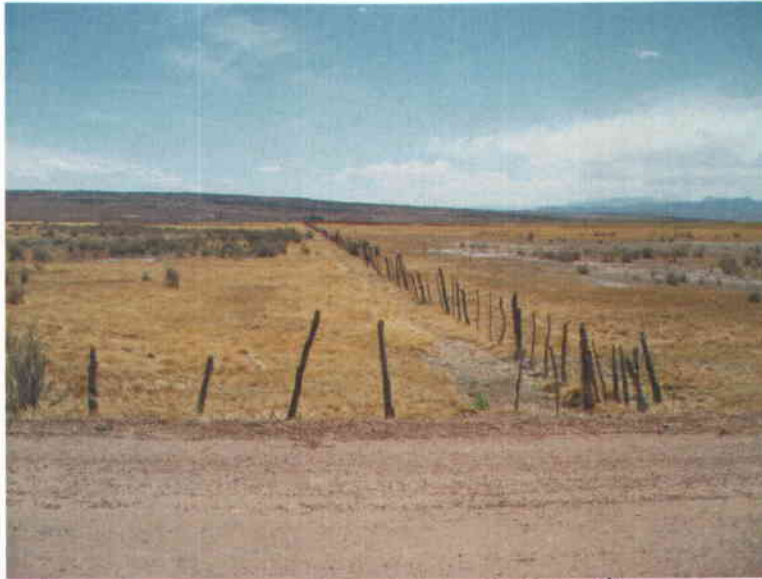
Looking south from the northeast corner of Panel 3 North. The 4<sup>th</sup> East Portal is visible in the distance just right of the fence. Panels 2 North, 3 North, and 1 through 4 West are located between the portal and where this photo was taken. This area is used primarily for irrigated crops and pasture.

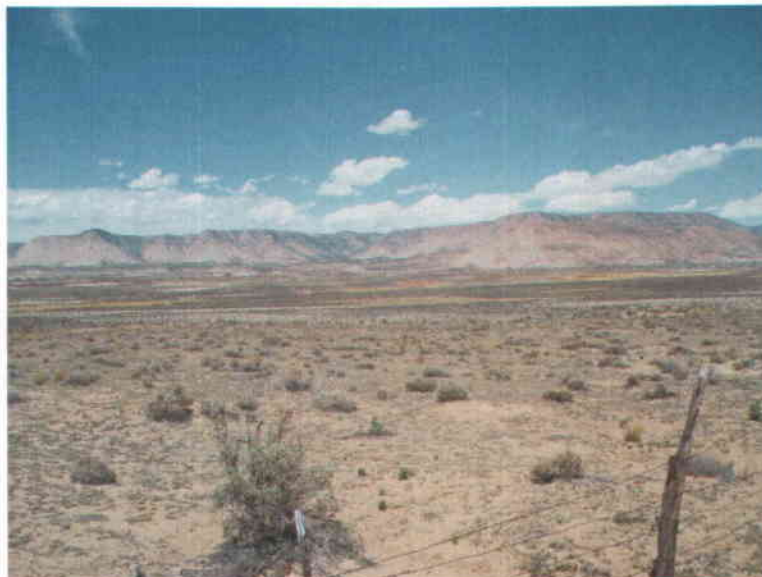
Looking northwest over Panels 0 and 1 North, 4 and 6 West, and 2 through 4 North in the distance.

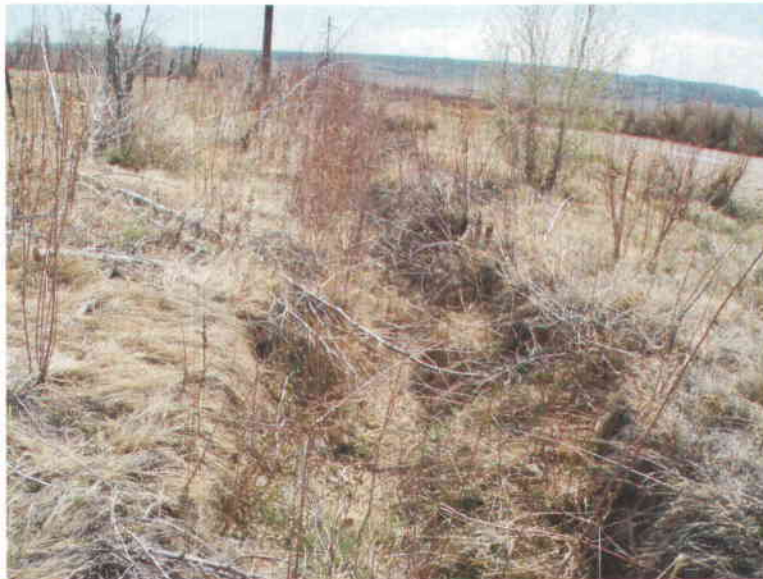
Feature 72. Irrigation Ditch. This feature has been updated from the Valley Engineering (1980) report. This ditch has earthen banks, is approximately three feet deep, and ranges from five to eight feet wide. There was no water within the ditch when it was surveyed in May 2008, but moist soil in its bottom suggested that it had been used recently. Water within the ditch flows from west to east until it reaches the paved road. From this point, water is diverted to the south through a culvert under the gravel road, and then east again under the paved road.

Feature 72. Irrigation Ditch. Looking east.

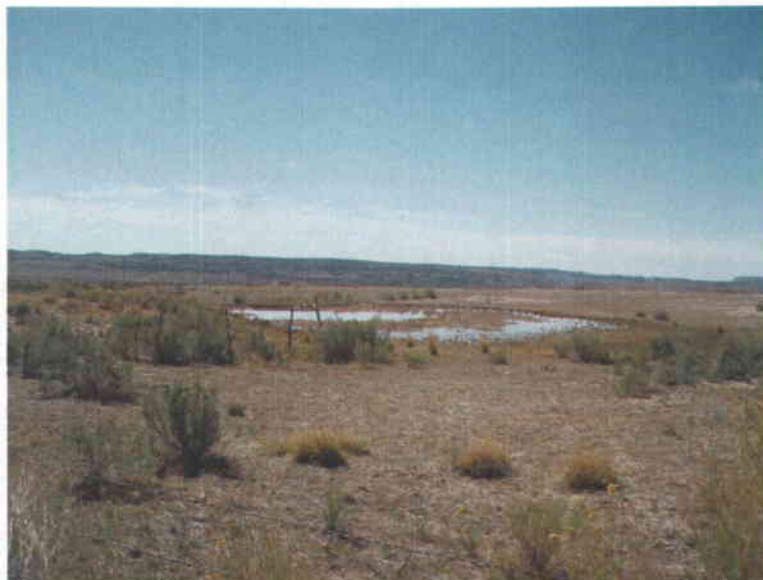
Feature 73. Pond. This feature has been updated from the Valley Engineering (1980) report. The pond is approximately 100 feet in diameter and was partially full when it was surveyed in May 2008. An approximately 5-foot tall earthen embankment runs along its downstream edge.

Feature 73. Pond. Looking southeast.

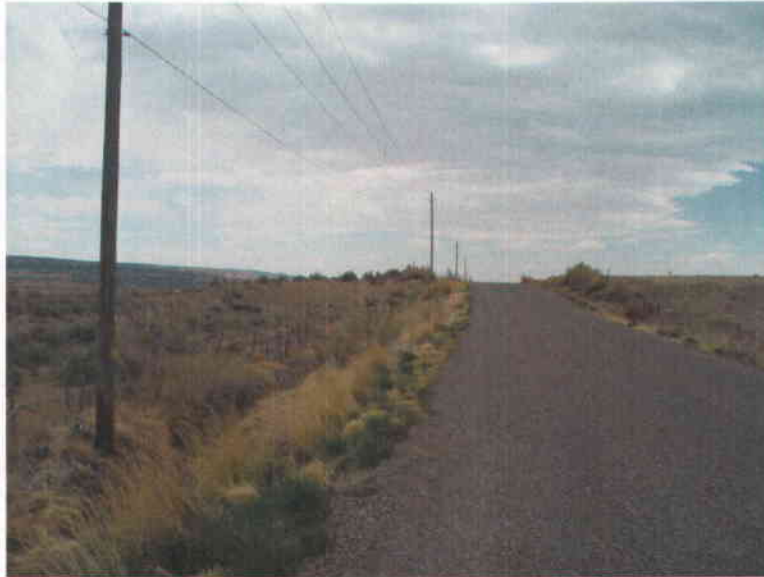
Feature 74. Irrigation Ditch. This feature is essentially unchanged from how it is described in the Valley Engineering (1980) report, which states the following: "The earthen

bank ditch is approximately 1.5 feet to 2 feet wide and 1 foot to 1.5 feet deep. Vegetation is growing along its banks.”

Feature 74. Irrigation Ditch. Looking south. The ditch is located on the left side of the road and is fed by a culvert running under the road located near where this photo was taken.

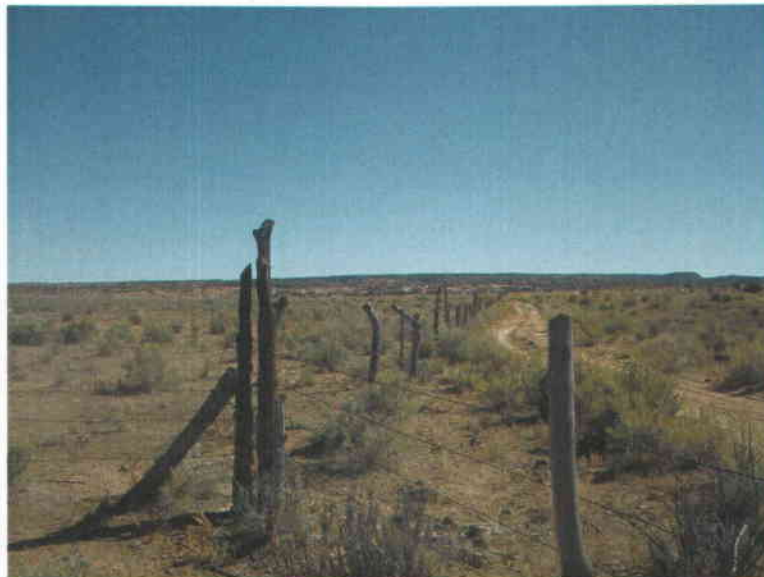
Feature 85. Dirt Road and Fences. This feature is essentially unchanged from how it is described in the Valley Engineering (1980) report, which states the following: “The road is a two-track, single lane, dirt road. The road surface consists of the natural sand and clay that is in the area, and has been compacted by vehicles that travel the road. The fences in the area are barbed wire with either natural rough cut wood posts or steel posts.” The fences are in fair to good condition.

Feature 85. Dirt Road and Fences. Looking west.

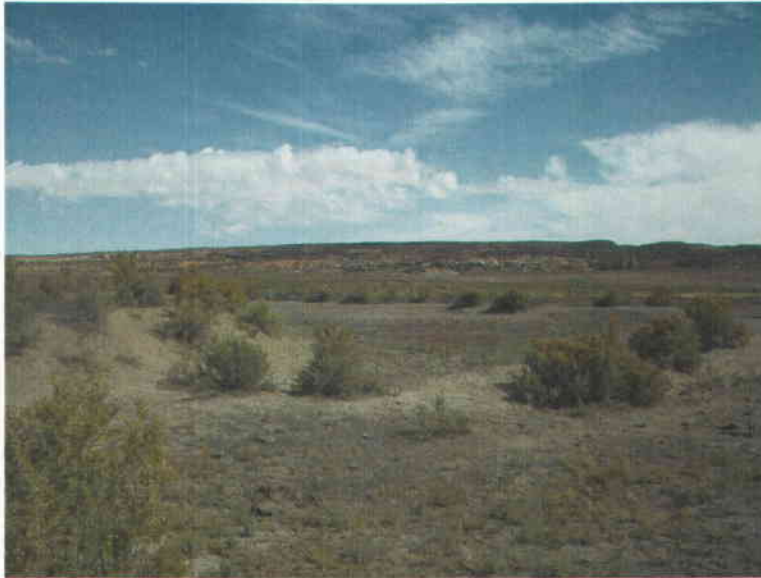
Feature 90. Ponds. The description of this feature has been updated from the Valley Engineering (1980) report. The ponds were empty during an October 2007 survey, but four earth berms were present that appeared capable of impounding water. The berms are approximately 3 feet tall. Three of the berms are clustered together in a north to south alignment, and one berm is located a few hundred feet to the northeast. A dry irrigation ditch located west of the three clustered ponds appears to serve as a water source. A dilapidated wooden corral and small shed is located just north of the three clustered ponds.

Feature 90. Ponds. Looking east.

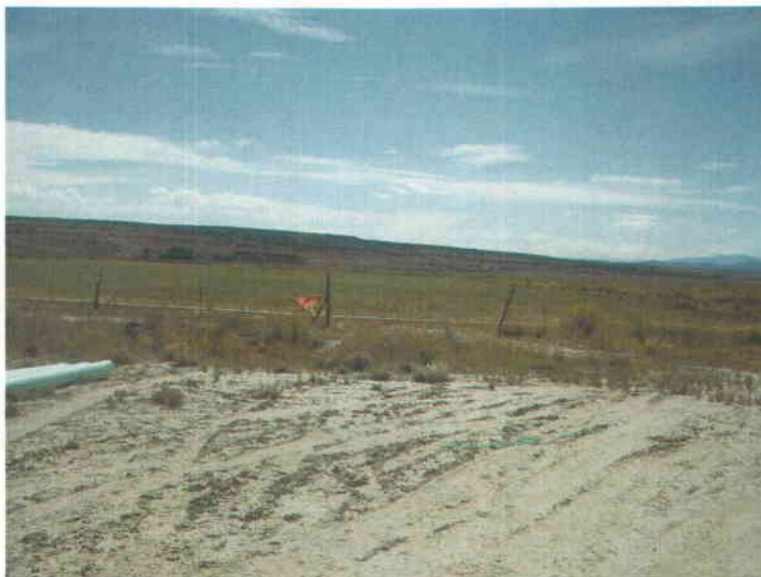
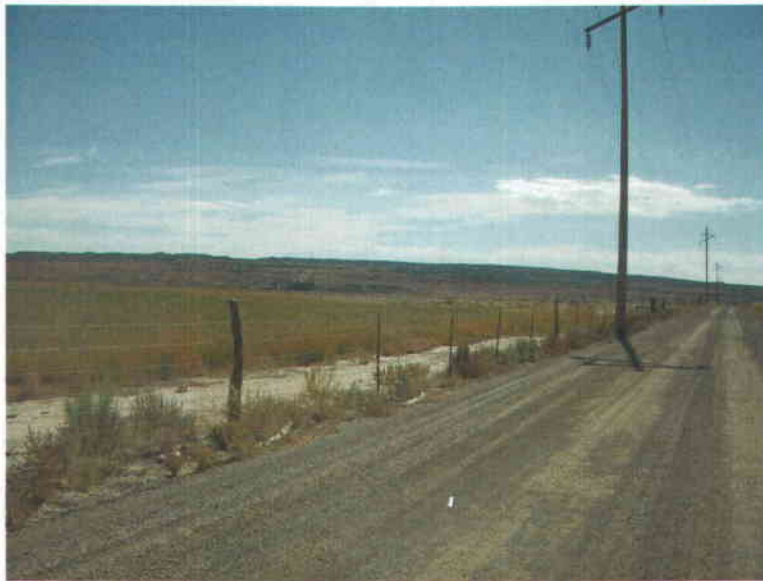
Feature 93. Irrigation Ditches and Farmland. The description of this feature has been updated from the Valley Engineering (1980) report. It contains 4 irrigated fields that comprise a total of 48 acres of cultivated land. Irrigation water flows from northwest to southeast and is supplied by the ditch running along the gravel road located east of the field.

Feature 93. Irrigation Ditches and Farm Land. Looking south.

Feature 93. Irrigation Ditches and Farm Land. Looking southeast. The farmland is located left of the road.

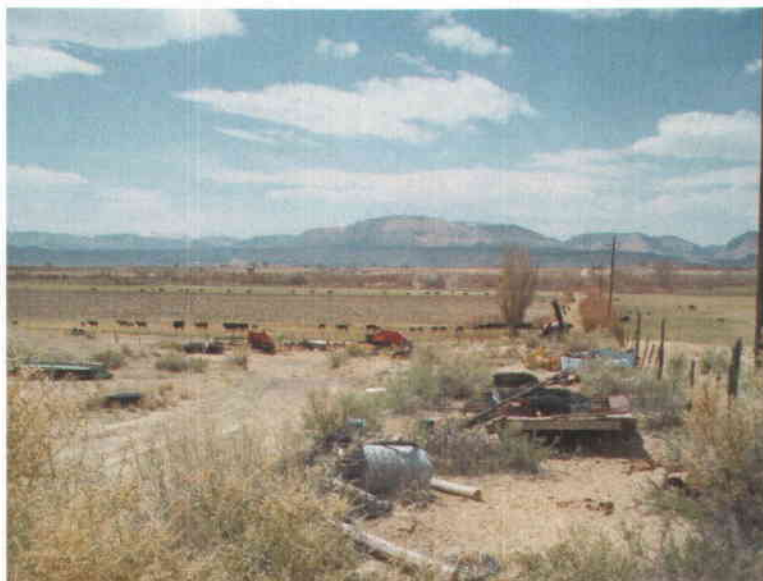
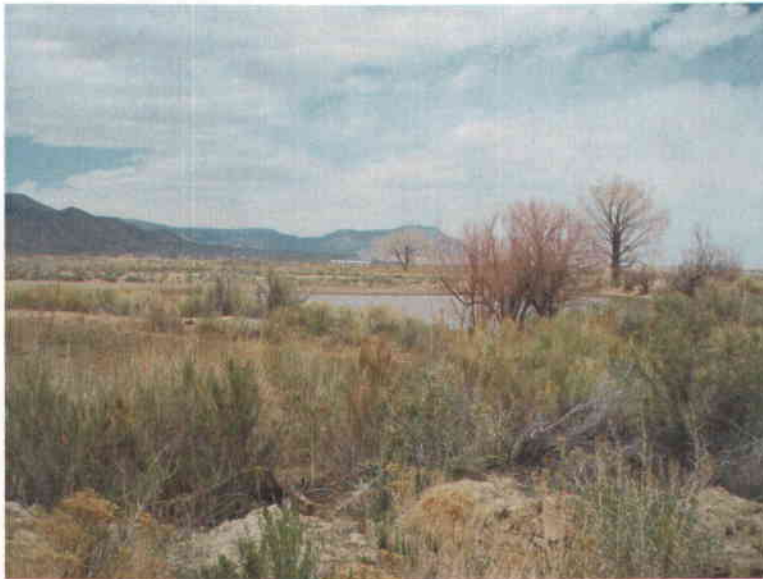
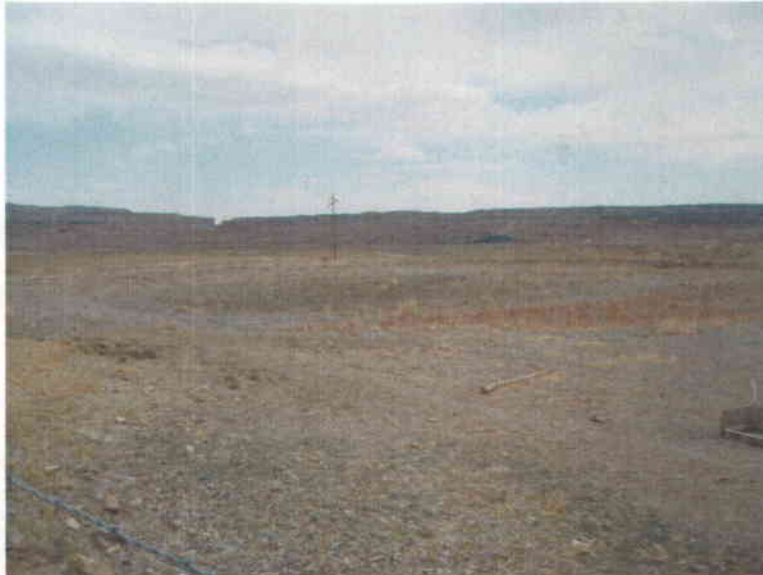
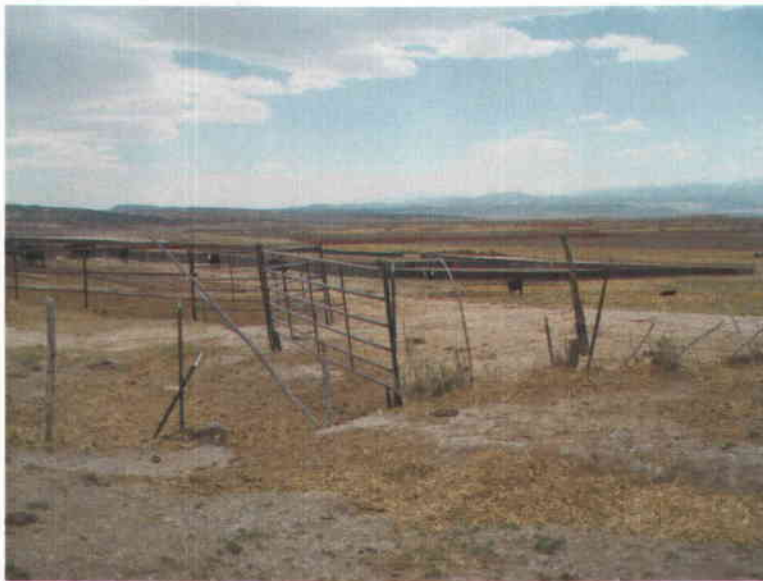
Feature 103. Farm Land, Corrals, Ponds, and Fences. The description of this feature has been updated from the Valley Engineering (1980) report. A fenced and gated hay storage area is located in the southeast corner of this feature. The fence and gate are in good condition. An unimproved dirt road (good condition) leads from the gravel road up to the hay storage area. Three small ponds are located north of the hay storage area. The two ponds that are adjacent to the hay storage area measure approximately 100 feet in diameter and are up to 5 feet deep. A larger pond measuring 400 feet by 200 feet is located about 700 feet to the northwest. Irrigated farm land and corrals surround the hay storage area. The corrals are constructed from metal tee stakes, finished and unfinished timbers, and metal tubing. They appear to be in good condition. The irrigated agricultural land consists of three fields totaling 70 acres. Irrigation is performed with a network of irrigation ditches that flow in a northwest to southeast direction as well as a buried plastic water line. The water line is 12" in diameter and runs north to south for 900 feet under the northwestern-most irrigated field of this feature. Two additional buried water lines are scheduled for construction during summer 2008. An unimproved dirt road in fair condition located about 800 feet north of the hay storage area provides additional access to the fields and corrals.

Feature 103. Farm Land, Corrals, Ponds, and Fences. Looking west at irrigated fields along Christiansen Wash.

Feature 103. Farm Land, Corrals, Ponds, and Fences. Looking north at one of the ponds.

Feature 103. Farm Land, Corrals, Ponds, and Fences. Looking southeast at one of the ponds, which was not filled when the survey was performed.

Feature 103. Farm Land, Corrals, Ponds, and Fences. Looking southwest at the fences and corrals.

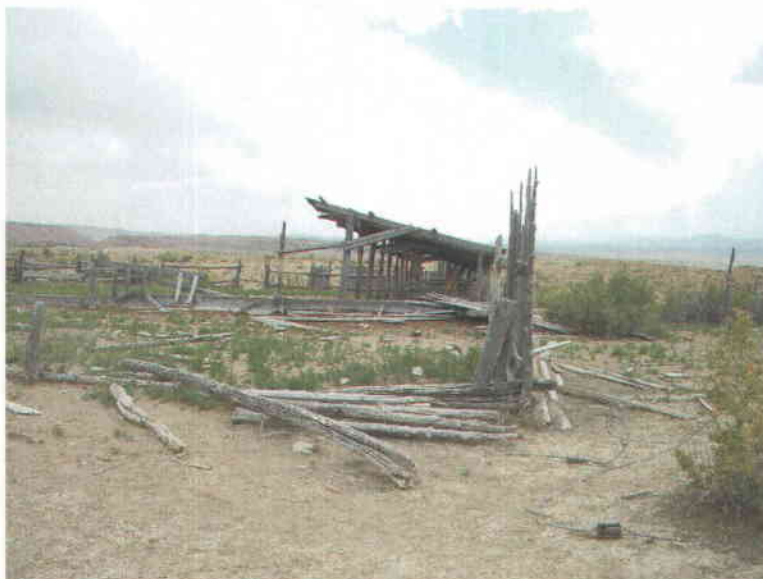
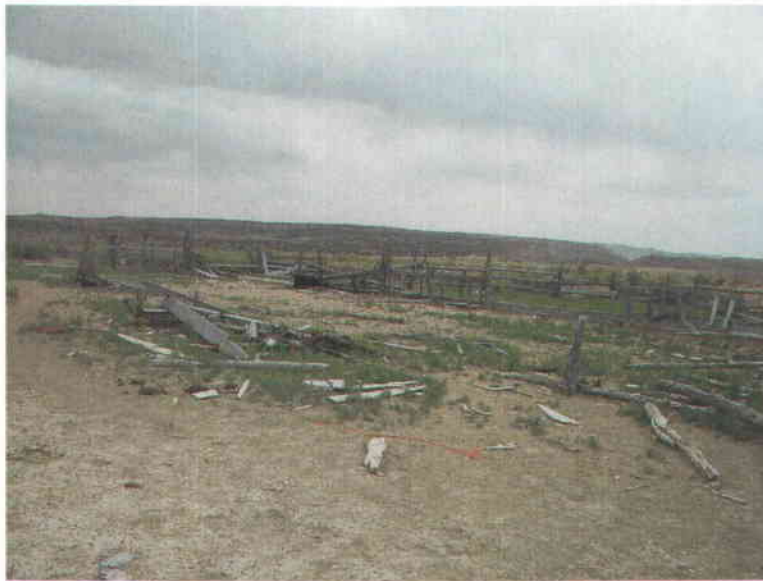
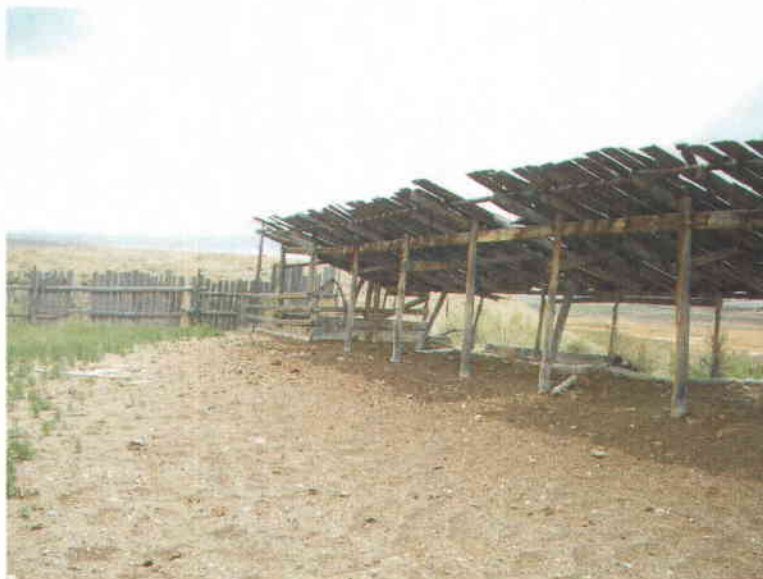
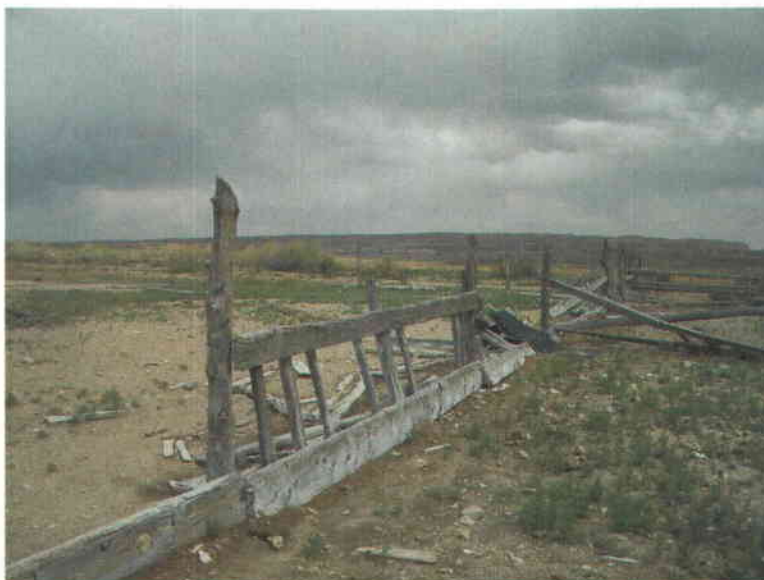
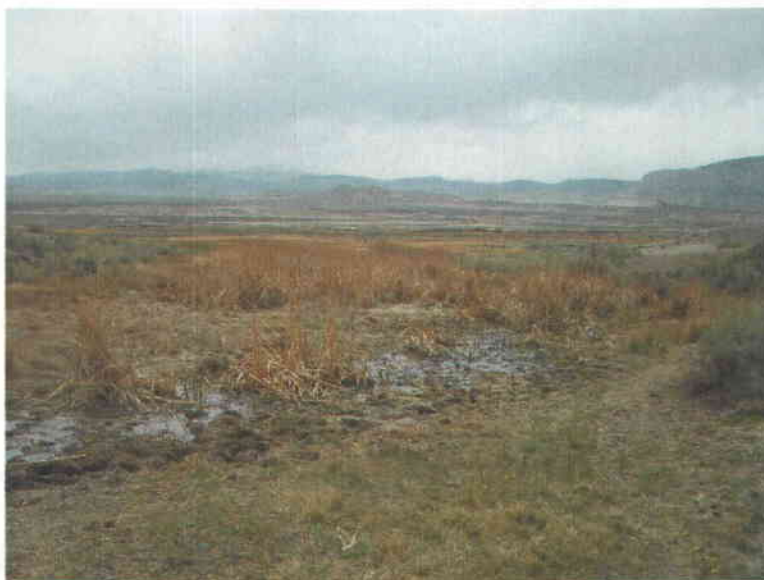
Feature 107. Corrals and Covered Shelters. The description of this feature has been updated from the Valley Engineering (1980) report. The corrals and shelters are in poor condition and are constructed of rough cut lumber and rough sawn boards. Several pieces of the fence are missing. The land slopes steeply downward just to the south of the corrals toward a broad, flat plain. During site reconnaissance, a marshy, grassy area was observed near the base of this slope. This marshy area corresponds to SP-9 on Plate VI-2/VI-2A and in the text of Chapter VI Volume 1 Section VI.A.2 (Springs and Seeps) of the Emery Mine Permit

(Consolidation Coal Company, 1990). As indicated in that permit document, SP-9 is the result of irrigation water and not a spring.

Feature 107. Corrals and Covered Shelters. Looking south at west portion of corral and covered shelter. (Photo taken April 2007)

Feature 107. Corrals and Covered Shelters. Looking southeast at east portion of corral and covered shelter. (Photo taken April 2007)

Feature 107. Corrals and Covered Shelters. Looking southwest at covered shelter. (Photo taken April 2007)

Feature 107. Corrals and Covered Shelters. Looking east along northern edge of corral. (Photo taken April 2007)

Feature 107. Corrals and Covered Shelters. Looking southwest at marshy, grassy area below and south of the corral and covered shelters. (Photo taken April 2007)

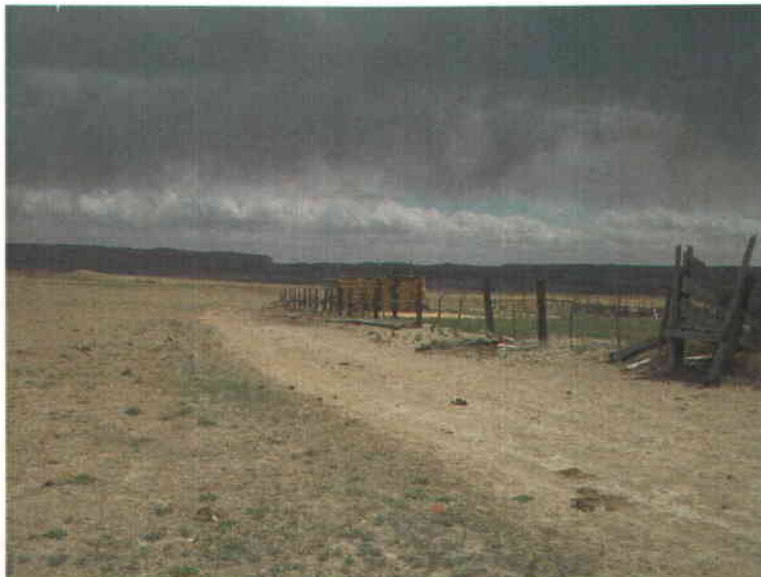
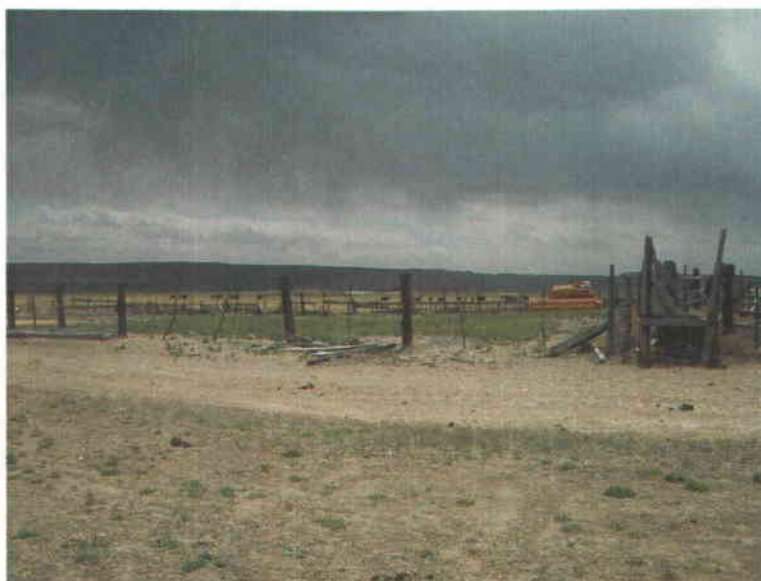
Feature 108. Corral. The description of this feature has been updated from the Valley Engineering (1980) report. This feature is in fair condition. It is constructed from square rough-cut wood posts, unfinished wood posts, and steel fencing reinforcement. Most of the corral is fenced with barbed wire. During site reconnaissance in May 2008, several hay bales were being stored in the corral, suggesting that it was being used

Feature 108. Corral. Looking southeast.

Feature 108. Corral. Looking south.

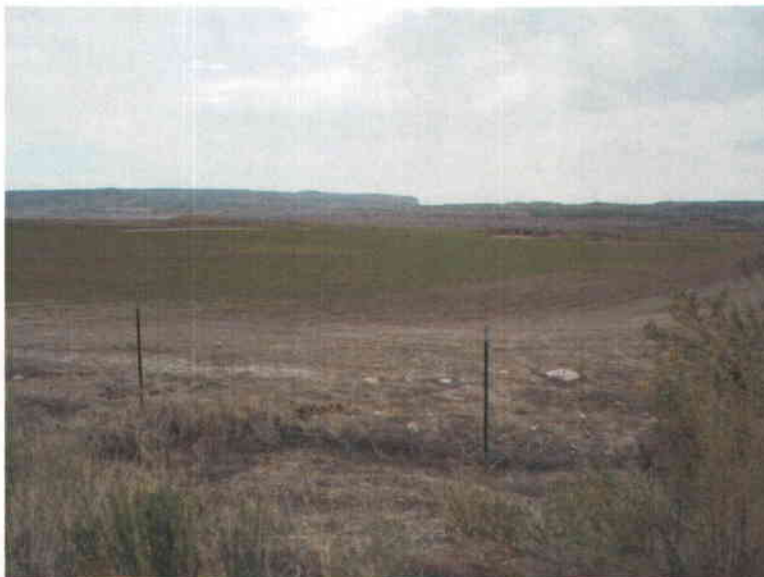
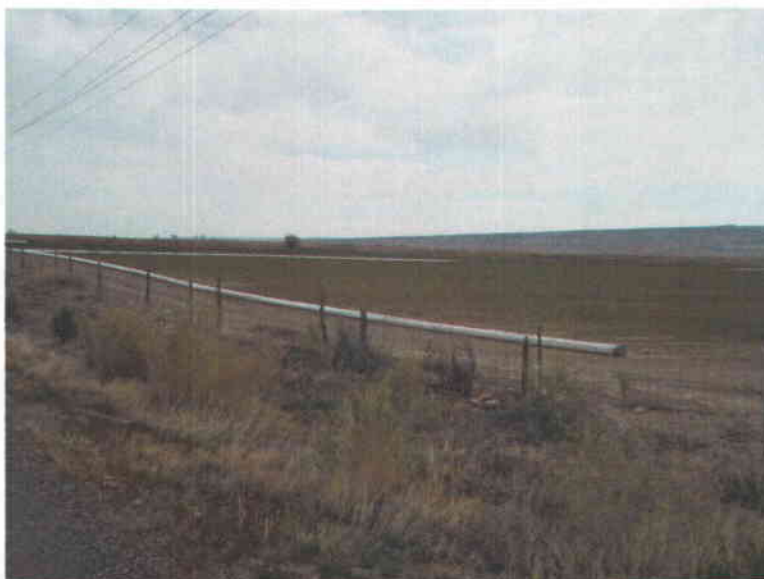
Feature 109. Farm Land. The description of this feature has been updated from the Valley Engineering (1980) report. This area is used primarily for growing alfalfa, but there are some grassland areas used for pasture. Irrigation water is conveyed to the area via a network of piping and ditches that drains to the southeast. There is one small pond that has been constructed at this feature.

Feature 109. Farm Land. Looking east.

Feature 109. Farm Land. Looking northeast.

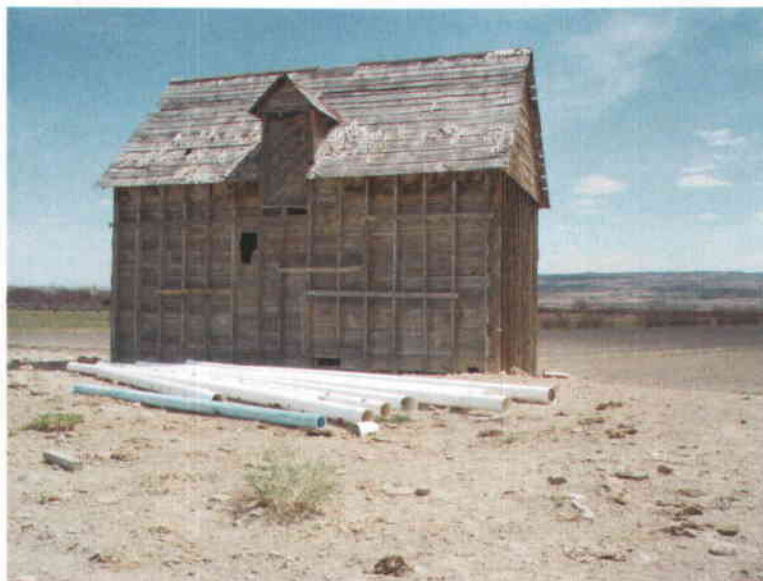
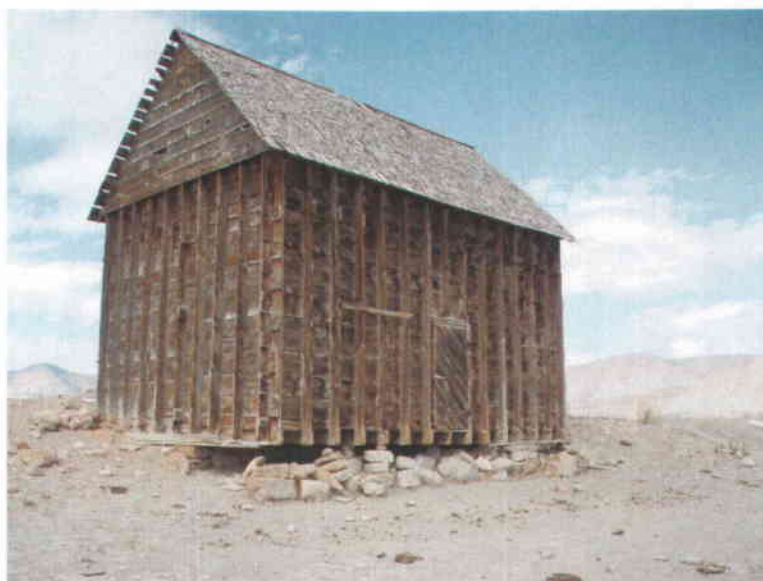
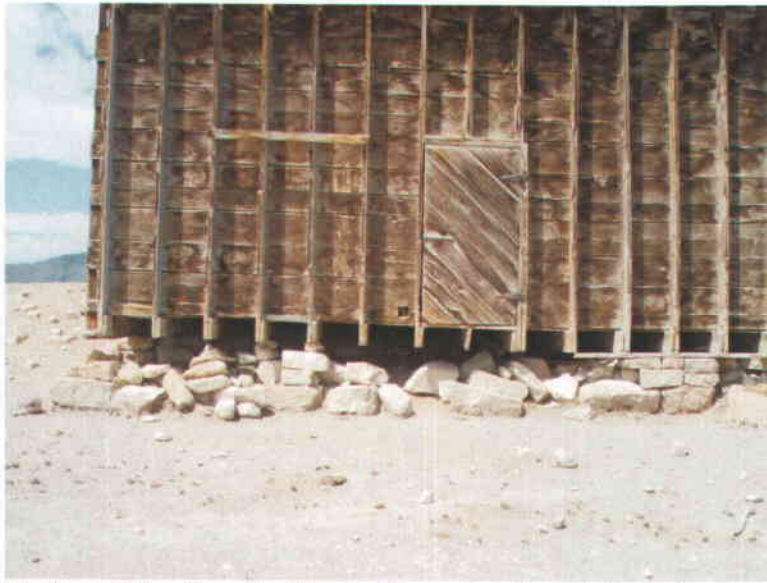
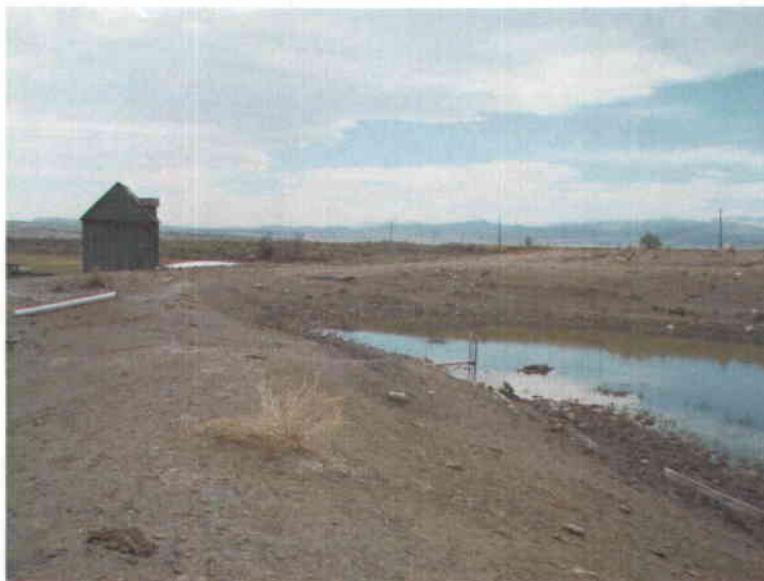
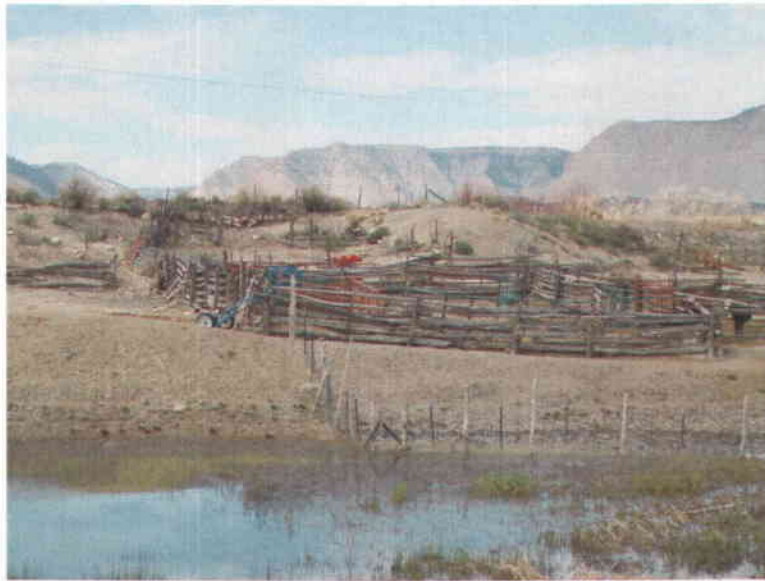
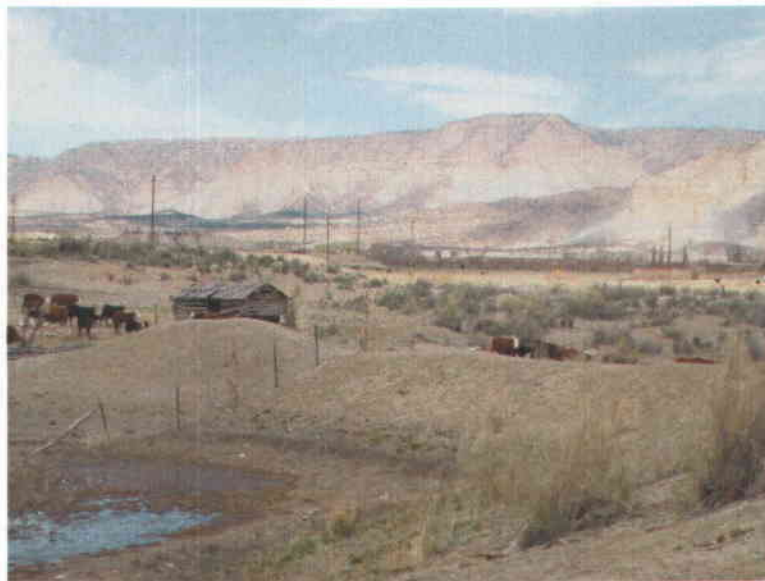
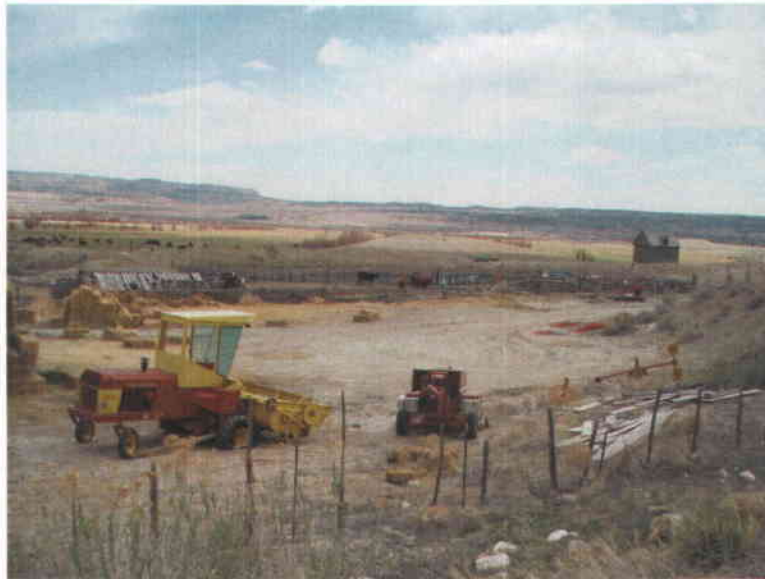
Feature 110. Corrals, Sheds, Barn, Pond, and Farm Land. The description of this feature has been updated from the Valley Engineering (1980) report. The corrals are constructed of unfinished and rough cut timbers as well as steel pipe fencing and are in good to fair condition. The sheds are constructed from rough cut logs and rough sawn boards and are in dilapidated condition. The roofs of the sheds have largely fallen apart. The barn is a two-story wood frame building in fair condition. It is founded on stacked rocks, which have started to fall over on the east side of the building. The pond measures approximately 300 feet long by 100 feet wide and has an earthen embankment that is approximately 10 feet tall on its east side. Irrigated fields of hay and grass covering an area of approximately 80 acres are located to the east and southeast of the corrals, barn, and pond.

Feature 110. Corrals, Sheds, Barn, Pond, and Farm Land. Looking east at barn.

Feature 110. Corrals, Sheds, Barn, Pond, and Farm Land. Looking west at barn.

Feature 110. Corrals, Sheds, Barn, Pond, and Farm Land. Looking west-southwest at foundation of barn.

Feature 110. Corrals, Sheds, Barn, Pond, and Farm Land. Looking south at pond and barn.

Feature 110. Corrals, Sheds, Barn, Pond, and Farm Land. Looking west across pond at corrals.

Feature 110. Corrals, Sheds, Barn, Pond, and Farm Land. Looking west at pond, corral, and shed.

Feature 110. Corrals, Sheds, Barn, Pond, and Farm Land. Looking southeast at corrals, shed, and farmland.

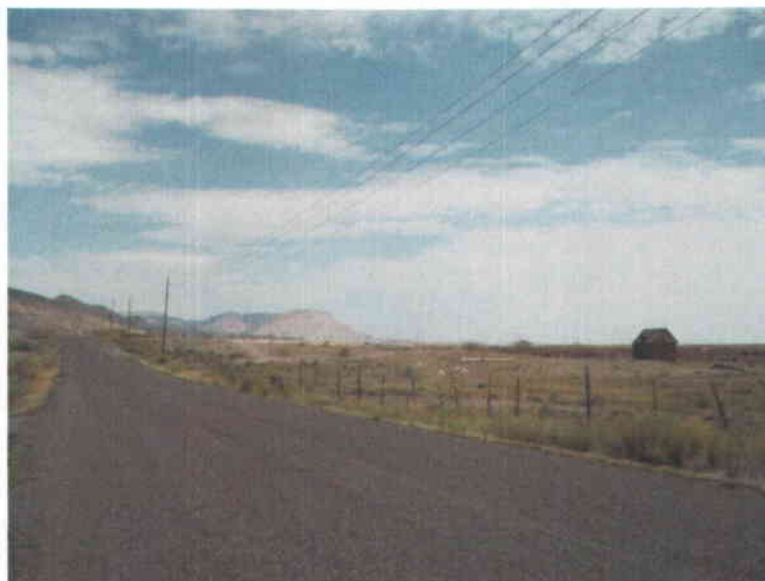
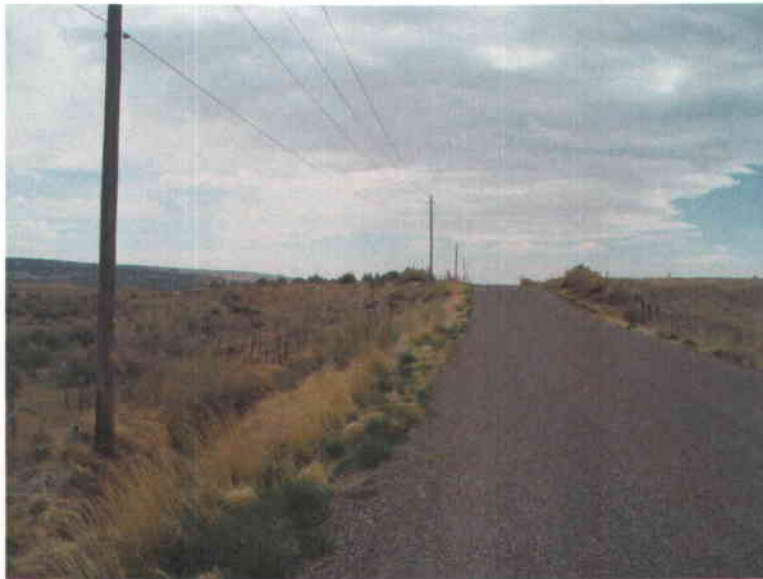
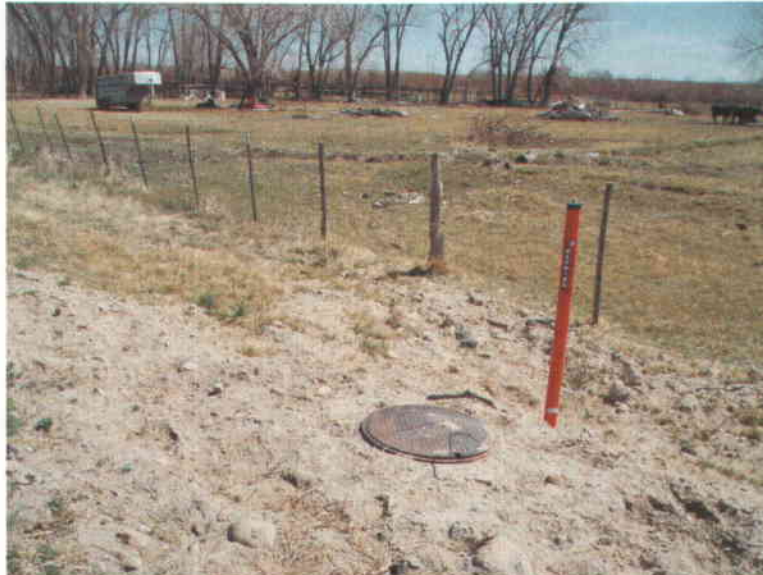
Feature 111. Gravel Road, Utility Power Lines, Telephone Lines, and Fence Lines. The description of this feature has been updated from the Valley Engineering (1980) report. The road

is surfaced with asphalt and is in good condition with few, if any cracks. An improved road surfaced with compacted gravel intersects the paved road from the west. The gravel road is in good condition. An overhead electric power line is located along the east side of the paved road and crosses over to run along the south side of the gravel road. Another overhead power line runs west to east along the north side of the gravel road, over the paved road, and across the adjacent pasture to the east. All of the power poles are in good condition, appear relatively plumb, and are about 40 feet tall. Orange markers that indicate the presence of a buried fiber optic cable are located along the north-south power pole alignment. Barbed wire fences run along both sides of the gravel and paved roads. The fences are in good to fair condition.

Feature 111. Road, Utility Power Lines, Telephone Lines, and Fence Lines. Looking north along the road. The barn in Feature 110 is visible in the right of the photo.

Feature 111. Road, Utility Power Lines, Telephone Lines, and Fence Lines. Looking south along the road. The barn in Feature 110 is visible in the center-left of the photo.

Feature 111. Road, Utility Power Lines, Telephone Lines, and Fence Lines. Looking northeast at a buried fiber optic cable manhole located below the power lines. Feature 113 is visible in the background.

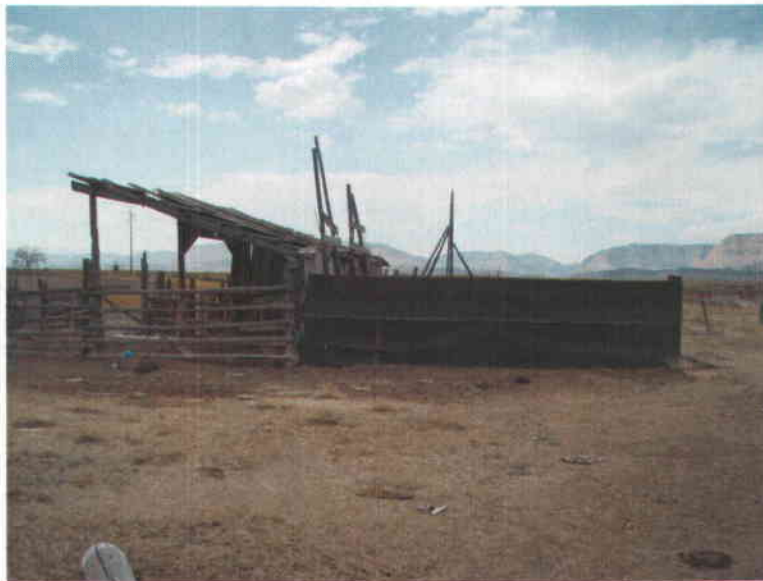
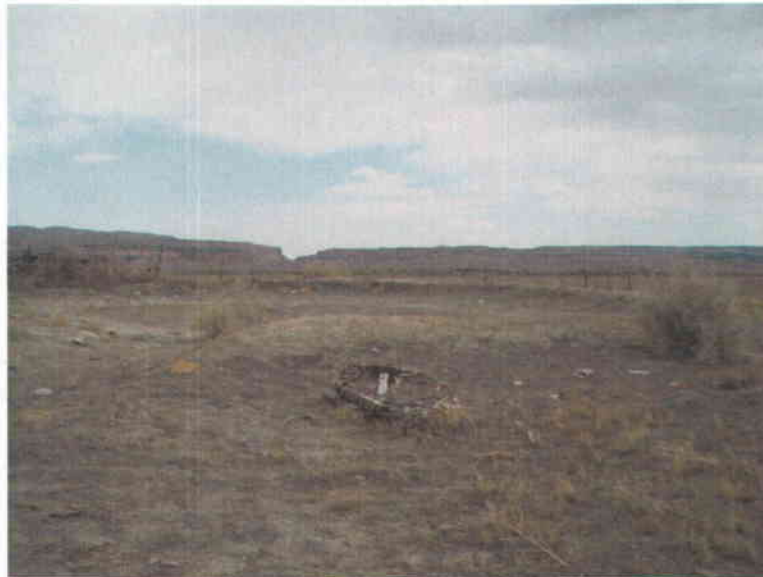
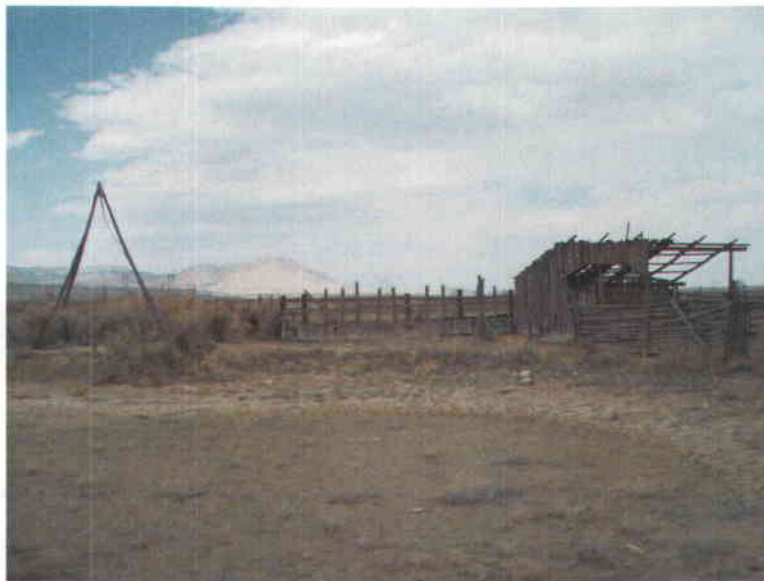
Feature 112. Corral. The description of this feature has been updated from the Valley Engineering (1980) report. This feature includes a corral, an animal shelter, remnants of a hay derrick, and two small ponds. The corral is constructed from rough-cut timbers, barbed wire, and conveyor belt material. It is in fair condition. The animal shelter is also constructed from rough-cut timber and is in dilapidated condition. Large sections of the roof are missing. The hay derrick is in fair to poor condition. The two ponds, which were empty during the Spring 2008 survey, are approximately 85 feet in diameter and have constructed with earthen embankments approximately 3 feet tall.

Feature 112. Corral. Looking west. The hay derrick is visible in the background.

Feature 112. Corral. Looking southeast at empty pond located east of corral.

Feature 112. Corral. Looking north at corral, shelter, hay derrick, and empty pond (in foreground).

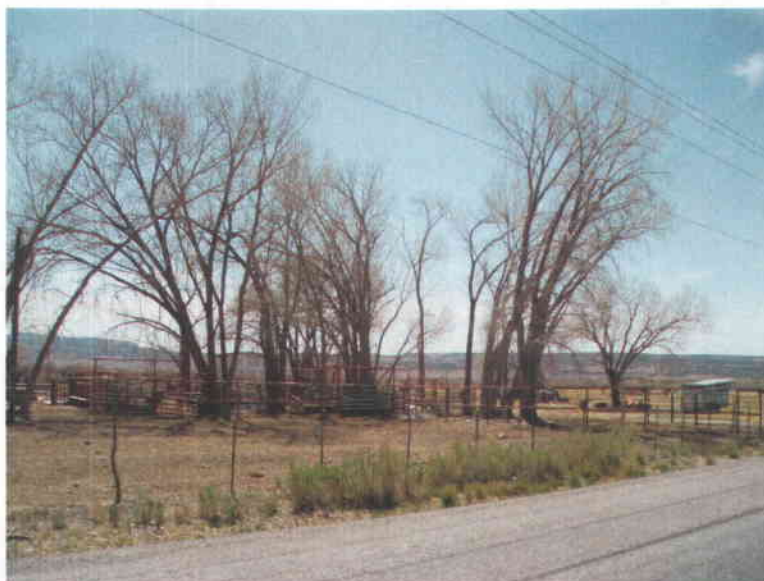
Feature 113. Corral. The description of this feature has been updated from the Valley Engineering (1980) report. The corral is constructed from both rough-cut timbers and painted metal tube fencing. The corral has been partitioned into several small areas. It is in good condition.

Feature 113. Corral. Looking southwest.

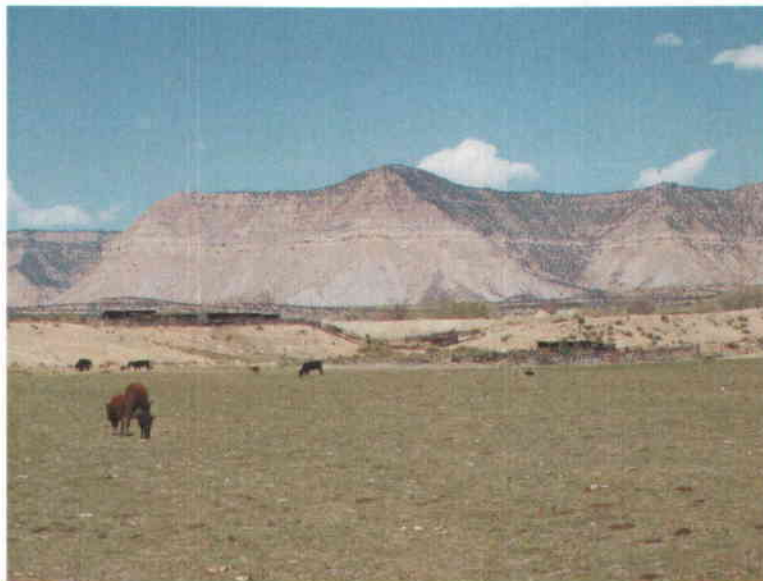
Feature 114. Corrals. The description of this feature has been updated from the Valley Engineering (1980) report. The corrals are constructed from rough-cut timbers which comprise the fence posts, fencing material, and sheltered areas. Hay was stored in one of the sheltered areas during the May 2008 survey. The corrals and shelters are in poor condition.

Feature 114. Corrals. Looking west. The corrals are in the distance. They were not directly accessible during the Spring 2008 survey due to the presence of livestock.

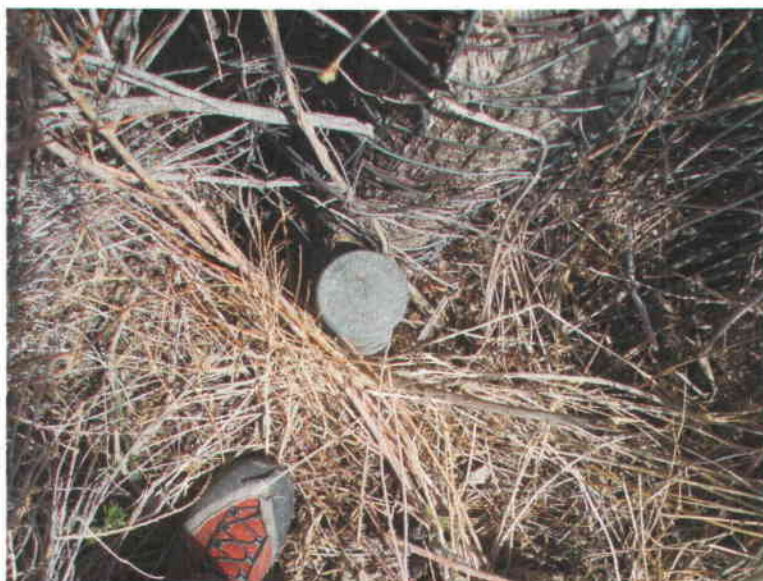
Feature 118. Section Corner Marker. This feature remains the same as described in the Valley Engineering (1980) report, which states the following: "This corner marker is located in Range 6 East Township 22 South. The marker is a metal cap on top of a short steel pipe. The marker is located at the intersection of Sections 20, 21, 28, and 29."

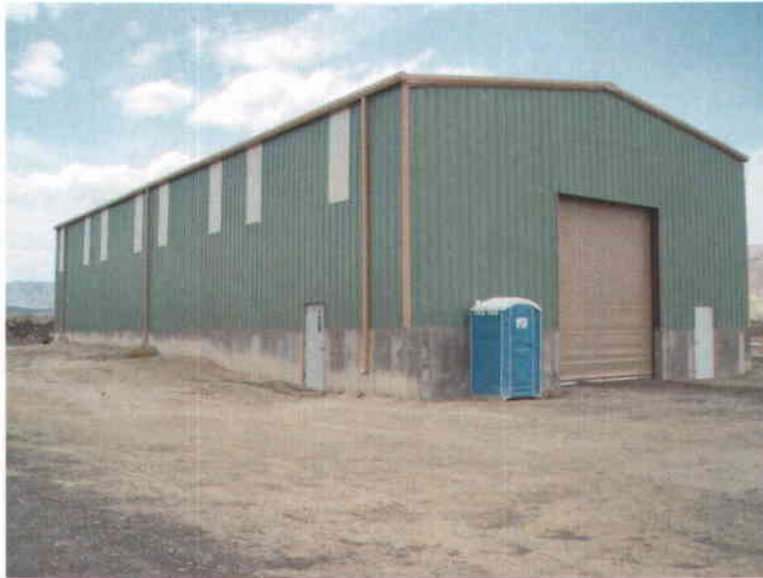
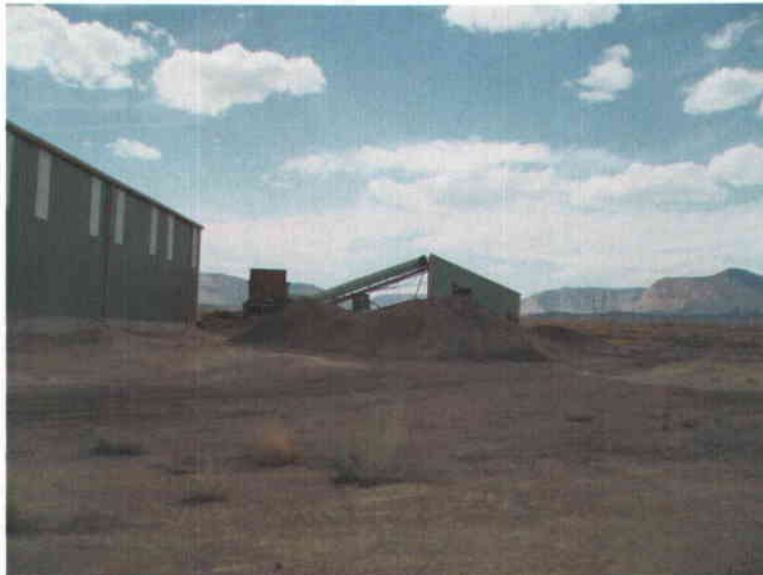
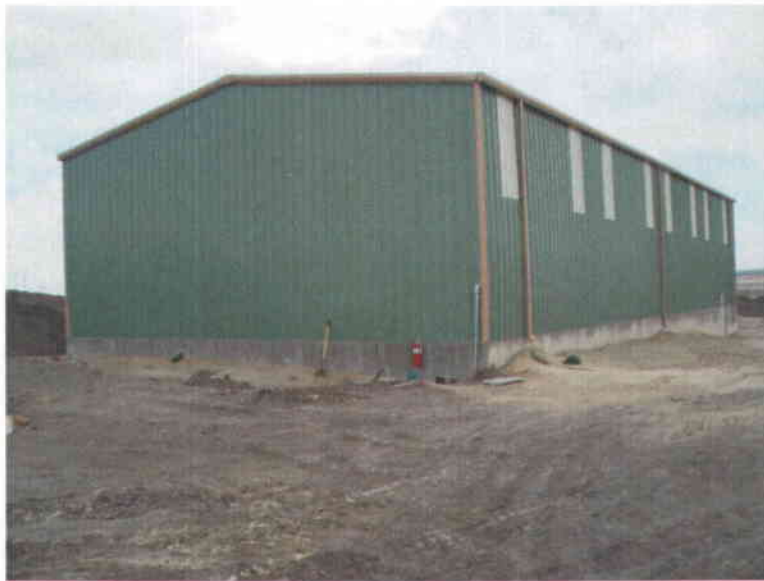
Feature 124. Shed. This feature was constructed after the Valley Engineering (1980) report was written. It is located about 1,000 feet north of the area scheduled for full extraction. The shed is built from corrugated metal with a concrete foundation and measures approximately 100 feet long by 40 feet wide by 30 feet tall. It is in excellent condition. A rock crusher is located adjacent to the shed on its northwest corner. An unimproved dirt road in fair condition leads from the graded gravel-surfaced road to the shed.

Feature 124. Shed. Looking west.

Feature 124. Shed. Looking southwest along side of shed at crusher.

Feature 124. Shed. Looking east.
